## RESTORATION PROCESS

### SAINT JOHN THE EVANGELIST NAVEGATING THE SHIP OF THE CHURCH

ATRIBUTED LEONARDO FLORES

Lis Sebastián. Restoration Department. Colnaghi Madrid.

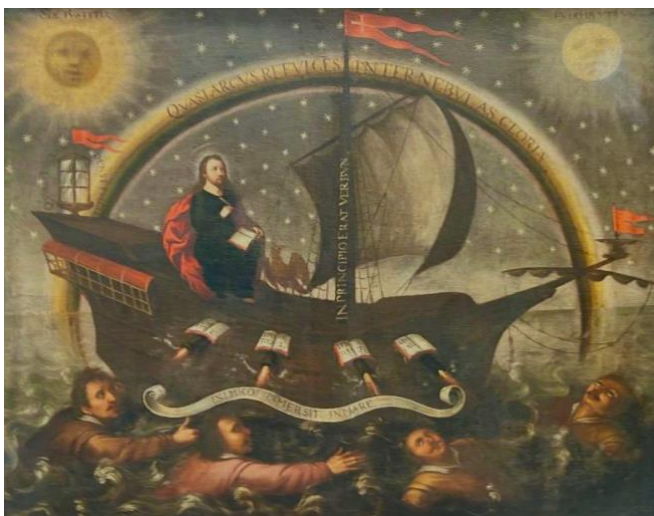
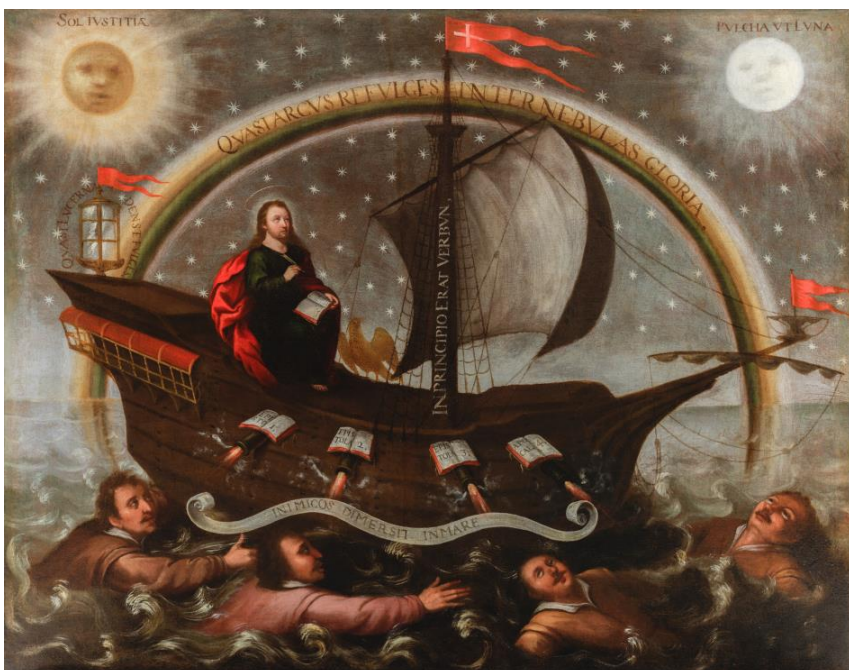
#### Initial and final state of the work

Both photographs show a comparative view of the state the painting was in before the restoration process began and the result after the process.

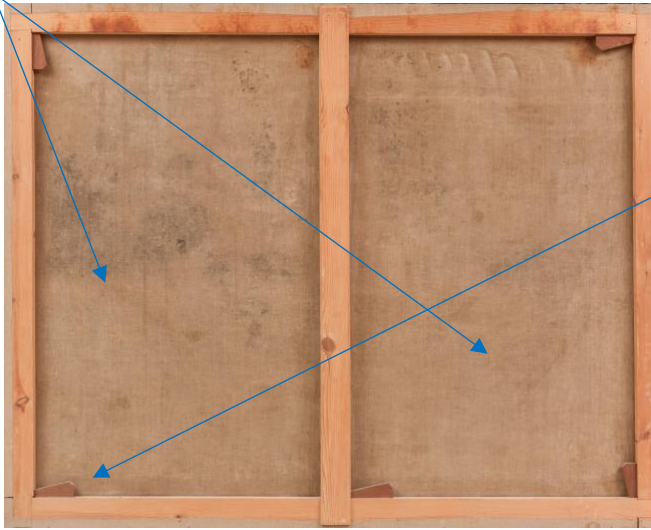
Full lining support.

The stretcher has all keys present but it doesn't have keys-retainers.

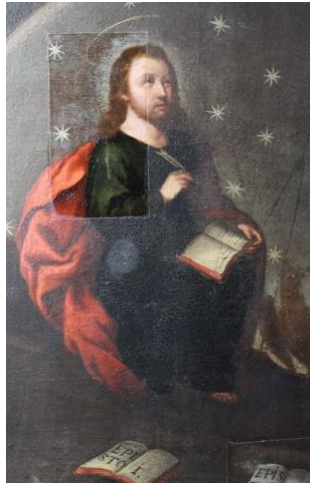
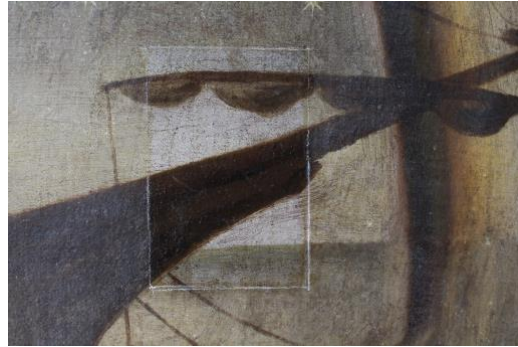
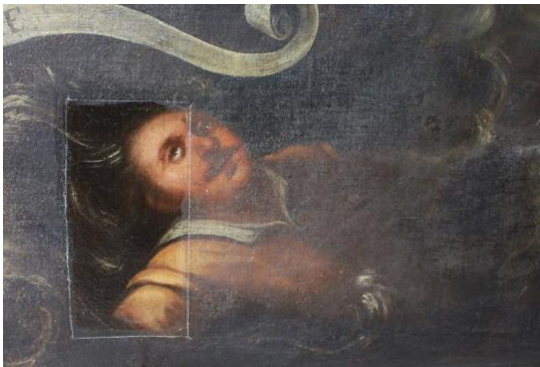
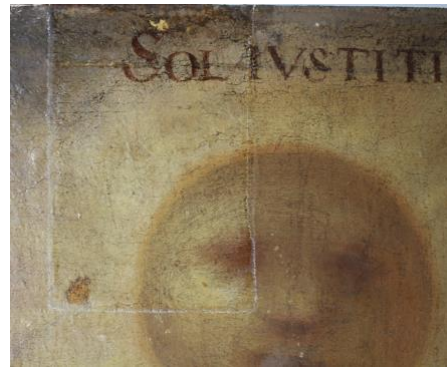
### Cleaning process

Over time, the varnish deteriorates, and the resin oxidises, turns yellow and crystallises, and over time layers of environmental dirt accumulate on the surface, together with smoke from old candle lighting. All this forms a dark film that prevents the original colours of the work from being seen.

The removal of the different layers of varnish and environmental dirt it is carried out by chemical and mechanical cleaning, according to the compositional characteristics of the resins to remove. The cleaning was carried out in two phases. The first one consisted in the elimination of the superficial varnish and the second one eliminated surface over paintings and old dirty.

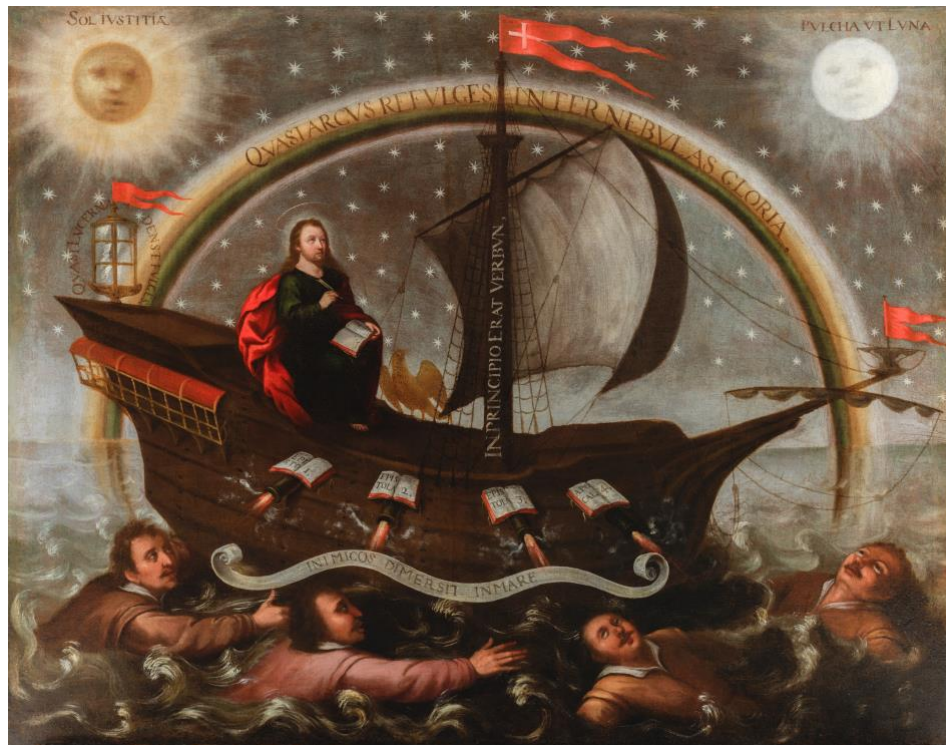
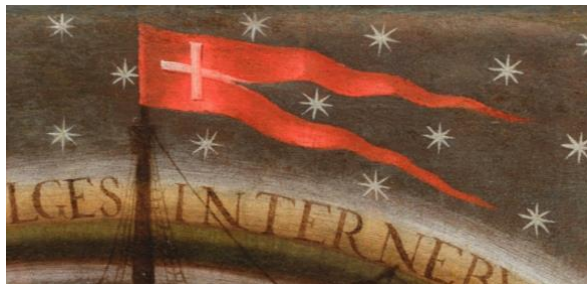
## Final state

The painting is in a good state of conservation. It can travel under suitable transport and packaging conditions.

Finally, a varnish layer is applied with a spray gun to protect the colors from the environmental damage. Furthermore, it saturates the color tones for a proper display by the observer extends.
