## RESTORATION PROCESS

### SAINT JOHN THE EVANGELIST NAVEGATING THE SHIP OF THE CHURCH

ATRIBUTED LEONARDO FLORES

Lis Sebastián. Restoration Department. Colnaghi Madrid.

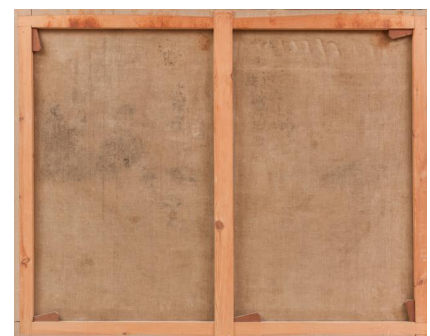
Reverse side of the work.

The canvas has a full lining from a previous restoration that is in good condition of conservation.

Dust and a surface dirt with stains can be shown on the back of the painting.

The stretcher will not be replaced because it is in a good condition of conservation, only cleaning is needed and has an auxiliary support. It has a vertical central cross bar which gives more stability to the frame structure.

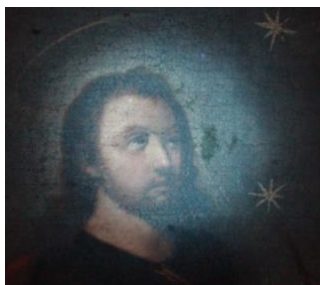
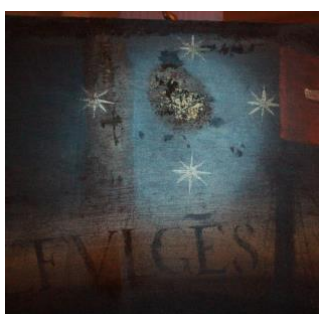
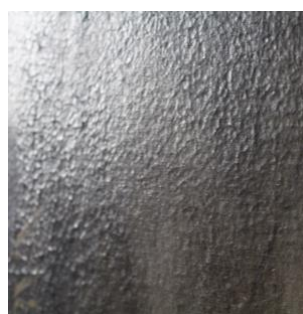
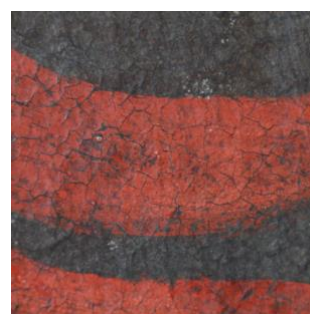
## Analytical Techniques Performed

The analysis done with ultraviolet light allows to see the areas of old over paintings. These can be distinguished because they take a dark purple color upon the varnish.
